Failure Analysis of Cracking on Side Tooth Gingivae of a Percussive Drill Bit

Zhao Tianliang¹, Liu Zhiyong^{1,2,*}, Du Cuiwei¹, Dong Chaofang¹ and Li Xiaogang¹

¹Corrosion and Protection Center, University of Science and Technology Beijing, Beijing 100083, China

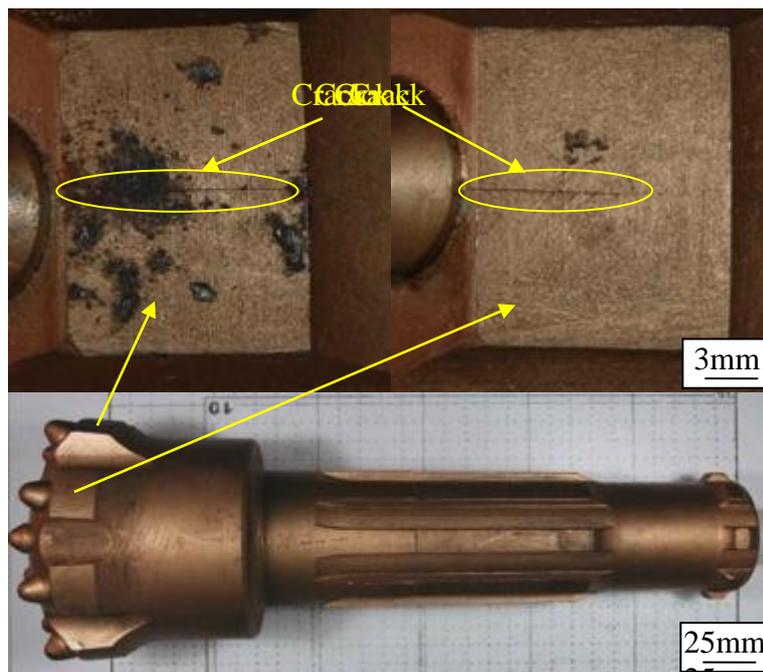
As shown in Fig. (1), cracks form on the tooth gingivae along the axial direction of the drill bit. Obviously, there are few signs of wear on it. It indicates that cracks formed before the drill bit was put into service. That is why we call it the unqualified drill bit. Fig. (2) shows the image of another worn-out drill bit. Conversely, cracks are not found on the counterpart of the worn one. We call it the qualified. It is also seen from Fig. (1) that crack line is very straight and fracture wall is vertical to the surface. It indicates that the tensile stress along the circumference direction induced by interference fit may directly respond for the crack initiation. However, there should be no difference of this stress between the unqualified and the qualified due to their identical interference fits. Therefore, whether the cracks are induced by excessive interference fit value or not still needs further investigations.

Fig. (1). Cracks on the side tooth gingiva of the unqualified drill bit.

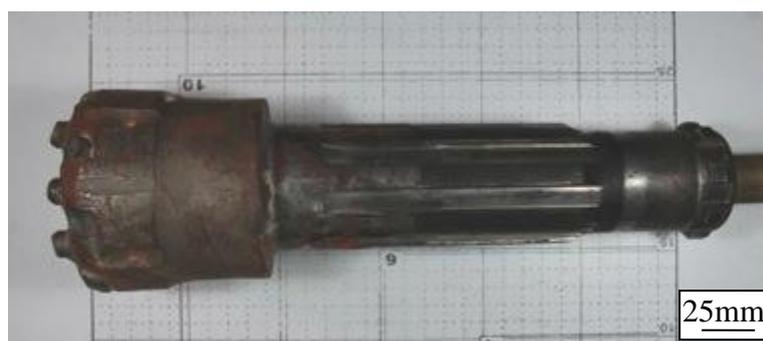
Fig. (2). The qualified drill bit scrapped after serving for a long time.

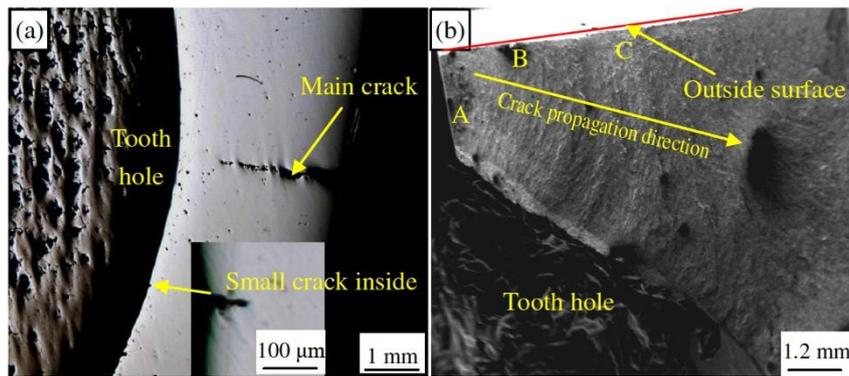
Micro-observations have been performed on the cracks and fracture wall by using SEM. Fig. (3a) is taken from the perspective of side face of the unqualified. It is seen that main crack propagates from the outside surface into the substrate and some small cracks initiate on the alveolus side. Fig. (3b) shows overall appearance of the fracture wall. Arc textures can be seen on the fracture wall. Based on those textures, origin and propagation direction of the main crack can be determined. As shown in Fig. (3b), the main crack initiates at the corner between A and B and propagates along the direction vertical to the arc textures. The plain fracture surface indicates that the cracking is characterized with embrittlement feature.

Fig. (3). (a) Cracks and (b) fracture wall on the side tooth gingivae.

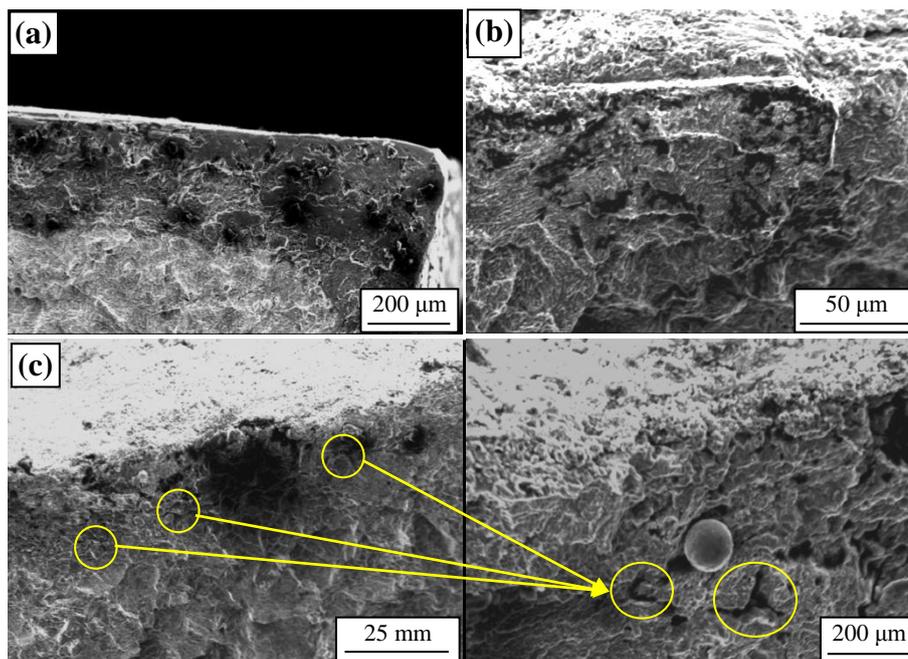
Fig. (4) shows microstructure of the fracture surface. Figs. (4a-4c) are respectively taken from places marked by A, C, B in Fig. (3a). It can be seen from them that excessive dark dots (Fig. 4a) and reticulation (Fig. 4b) and some loosens (Fig. 4c) distribute on the fracture wall near the outside surface. Fig. (4a) clearly exhibits that surface of the drill bit has been carburized. The gray area, which is apparently distinct from the white substrate, is identified as the carburized layer. Those dark dots and reticulation on it are believed to be the carbon-rich regions. Generally, they can be seen as harmful defects when they are not uniformly distributed. Fig. (4c) shows some loosens accompany those carbon-rich regions. All of them act as stress raisers and make the carburized layer risk crack initiation seriously under a uniaxial stress, which is especial for the high-strength steel [14 - 16].

Fig. (4). Defects in the carburized layer: (a) carbon-rich dots, (b) carbon-rich reticulations, (c) loosens.

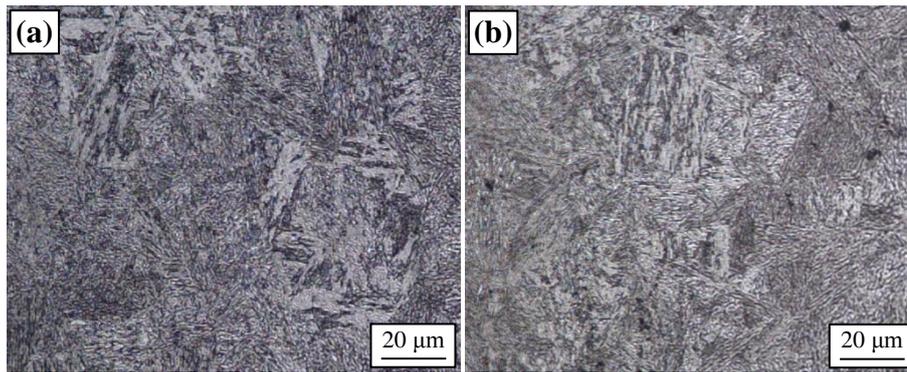
Images shown in Fig. (5) are metallographic structure of the substrate. Few differences of metallographic structure can be seen between the unqualified (Fig. 5a) and the qualified (Fig. 5b). They are both relatively pure acicular bainite, or it may be martensite due to high carbon content. It indicates that the cracking should not initiate from the substrate. Fig. (6) shows that numerous dark dots are dispersed in the carburized layer of the unqualified, which is barely seen in that of the qualified. Those dots represents the structural or/and compositional inhomogeneity, such as the carbon-rich dots. They are far denser than that in the substrate. It is consistent with what is seen in Fig. (4a).

Fig. (5). Metallographic structure of the substrates of (a) the unqualified and (b) the qualified respectively.

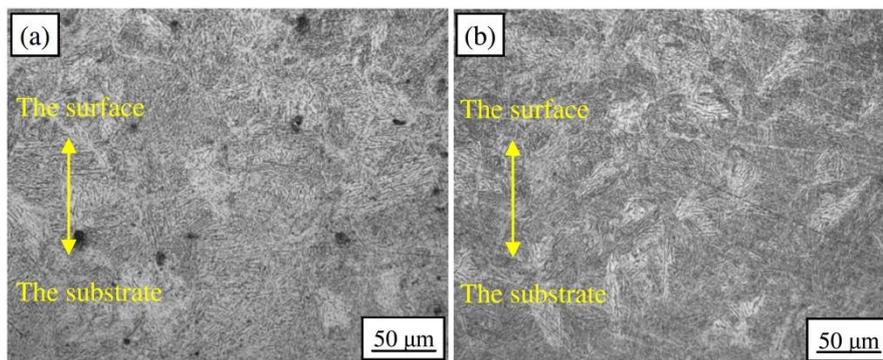
Fig. (6). Metallographic structure of the carburized layers of (a) the unqualified and (b) the qualified respectively.

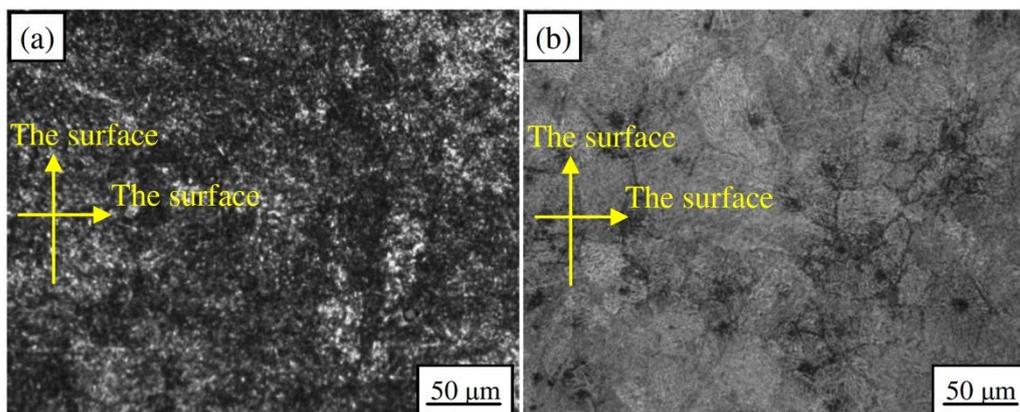
Metallographic observations have also been taken on the surfaces of the qualified and unqualified. The results are shown in Fig. (7a) shows that almost entire surface of the unqualified is blackened. Comparatively, that is much lighter on the surface of the unqualified, as shown in Fig. (7b). As they are etched in the same solution for the same time, this difference should not be induced by etching. It indicates that the unqualified has been over-carburized more seriously than the qualified.

Fig. (7). Metallographic structure of the surfaces of (a) the unqualified and (b) the qualified respectively.

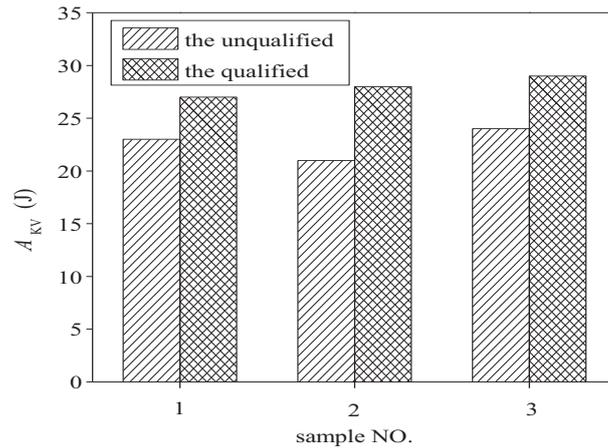
Fig. (8). Impact absorbing energy of the unqualified and the qualified drill bit.

Fig. (8) shows the charpy impact absorbed energy of three parallel V-notch samples cut from the unqualified and qualified respectively. Impact absorbed energy (A_{KV}) of the unqualified is about 20% on average lower than that of the qualified. It manifests that resistance to impact fracture of the unqualified deteriorate when compared to that of the qualified. But the degree is not great enough.

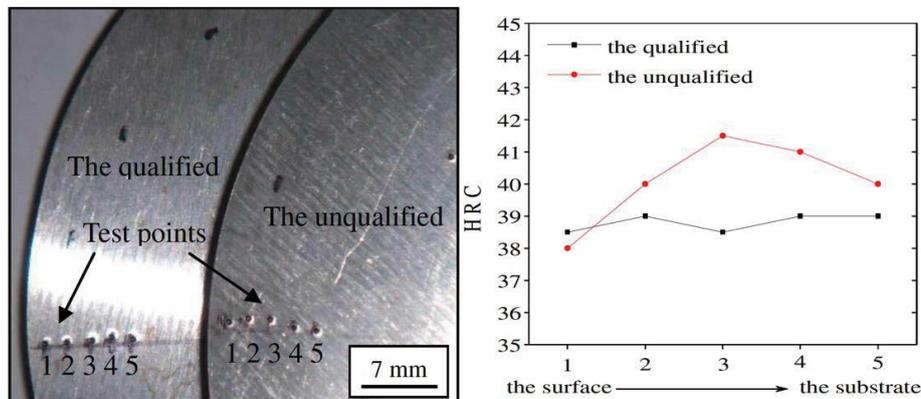
Fig. (9) shows the hardness distribution along the radial direction from the surface into the substrate. It indicates that hardness of the qualified is generally lower and distributes more uniformly than that of the unqualified. The inhomogeneity on hardness distribution reflects the inhomogeneity on internal residual stress and microstructure. Actually, difference between them is still in a rational range which can be taken as error of measurement. Besides, all of the five test points are located in the substrate. It indicates that the substrate of the unqualified possesses internal residual stress and microstructure similar to the substrate of the qualified. That is consistent with what is illustrated in Fig. (5).

Fig. (9). Hardness distribution along the radial direction from the surface into the substrate.

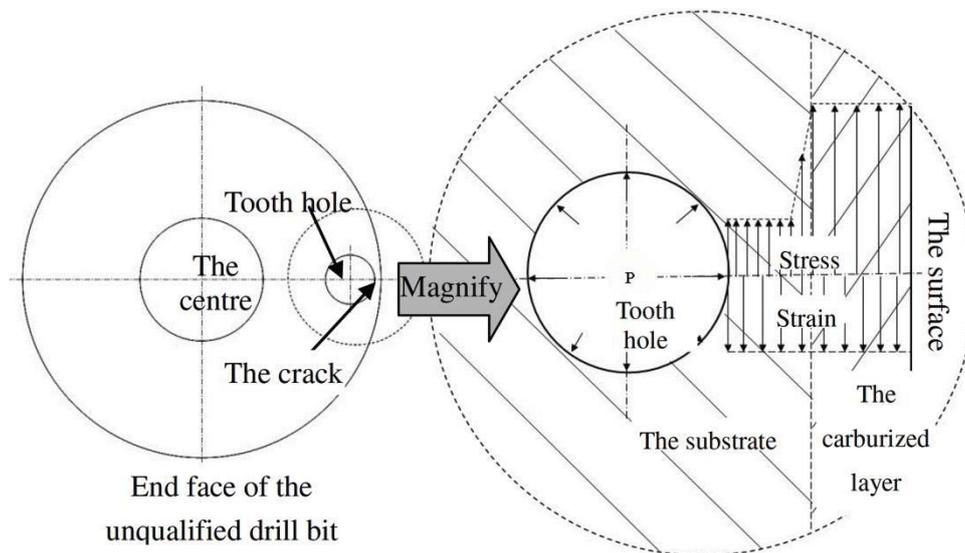
The drill teeth and the tooth holes are fastened by interference fit. Due to the different positions and asymmetry of tooth holes, tensile stress caused by interference fit generates a complex stress field at end face of the drill bit. According to previous study, the tensile stress level around the side teeth is much higher than that around the interior teeth [17]. Stress status on the edge of the end face nearby side teeth is simplified to the sketches shown in Fig. (10). The stress that the carburized layer suffered (σ_c) is much greater than the stress that the substrate suffered (σ_b). In addition, structure of the carburized layer is more defective than that of the substrate (see Figs. 5a, 6a). Greater stress and more defects make the carburized layer more likely initiate crack than the substrate do. Moreover, the stress concentration caused by structure asymmetry of fracture surface will further promote the crack initiation.

Fig. (10). Sketch of stress status around the crack on the edge of side tooth.

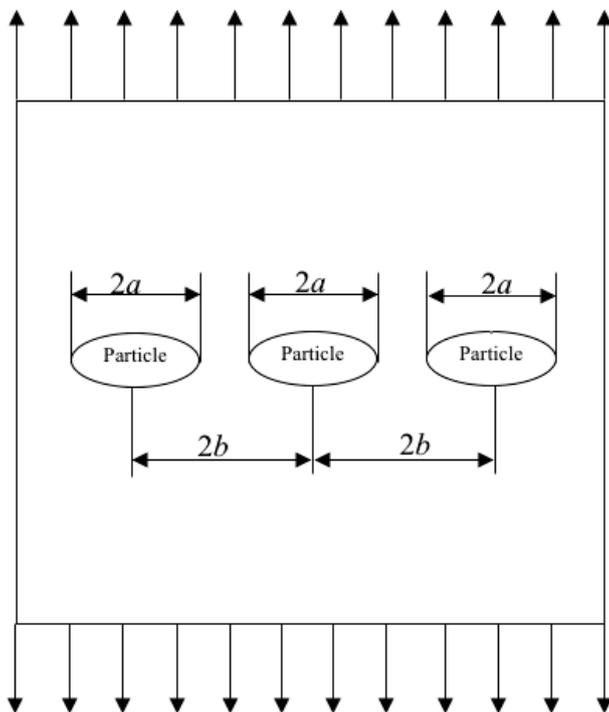
seen as ellipse particles. Fig. (11) illustrates the sketch of the stress unit. The radial stress can be ignored when compared with the much greater circumferential stress σ . The length of long axis is $2a$ and the distance between them along the axial direction is $2b$. According to fracture mechanics [18], fracture toughness of the carburized layer, K_{ICc} , can be expressed as follows:

Fig. (11). Stress unit containing defects in the carburized layer of the unqualified.
