The Open Materials Science Journal

Failure Analysis of Cracking on Side Tooth Gingivae of a Percussive Drill Bit

Zhao Tianliang¹, Liu Zhiyong^{1,2,*}, Du Cuiwei¹, Dong Chaofang¹ and Li Xiaogang¹

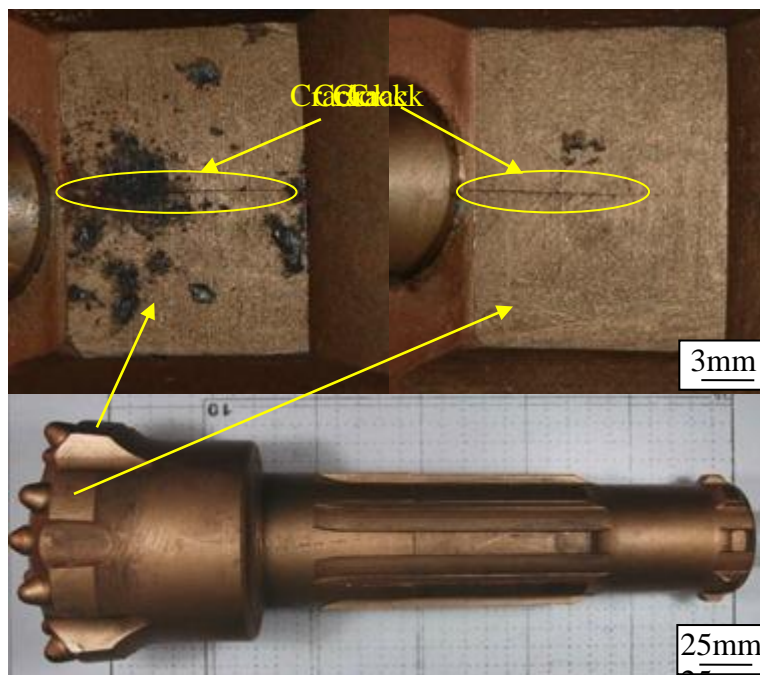
As shown in Fig. (1), cracks form on the tooth gingivae along the axial direction of the drill bit. Obviously, there are few signs of wear on it. It indicates that cracks formed before the drill bit was put into service. That is why we call it the unqualified drill bit. Fig. (2) shows the image of another worn-out drill bit. Conversely, cracks are not found on the counterpart of the worn one. We call it the qualified. It is also seen from Fig. (1) that crack line is very straight and fracture wall is vertical to the surface. It indicates that the tensile stress along the circumference direction induced by interference fit may directly respond for the crack initiation. However, there should be no difference of this stress between the unqualified and the qualified due to their identical interference fits. Therefore, whether the cracks are induced by excessive interference fit value or not still needs further investigations.

Fig. (1). Cracks on the side tooth gingiva of the unqualified drill bit.

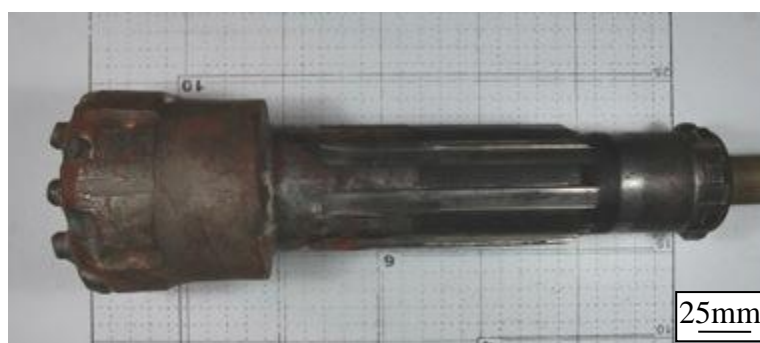
Fig. (2). The qualified drill bit scrapped after serving for a long time.

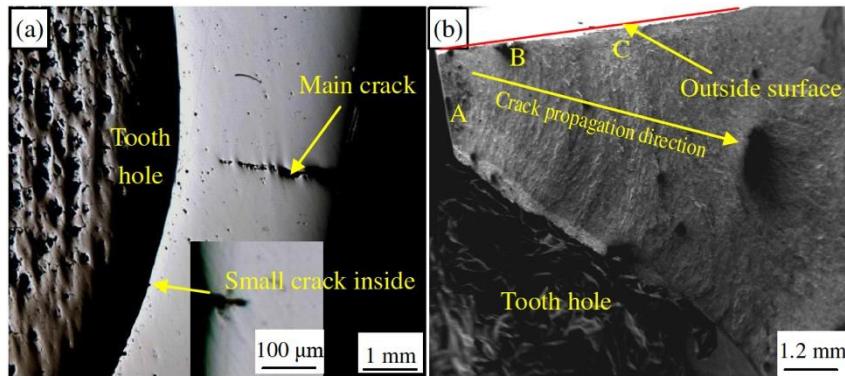
Micro-observations have been performed on the cracks and fracture wall by using SEM. Fig. (3a) is taken from the perspective of side face of the unqualified. It is seen that main crack propagates from the outside surface into the substrate and some small cracks initiate on the alveolus side. Fig. (3b) shows overall appearance of the fracture wall. Arc textures can be seen on the fracture wall. Based on those textures, origin and propagation direction of the main crack can be determined. As shown in Fig. (3b), the main crack initiates at the corner between A and B and propagates along the direction vertical to the arc textures. The plain fracture surface indicates that the cracking is characterized with embrittlement feature.

Fig. (3). (a) Cracks and (b) fracture wall on the side tooth gingivae.

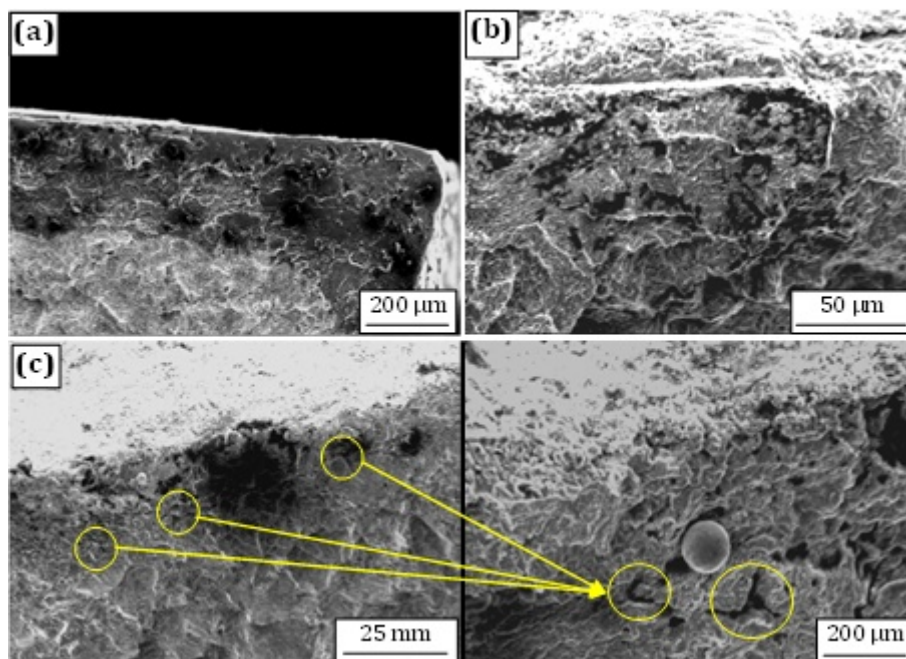
Fig. (4) shows microstructure of the fracture surface. Figs. (4a-4c) are respectively taken from places marked by A, C, B in Fig. (3a). It can be seen from them that excessive dark dots (Fig. 4a) and reticulation (Fig. 4b) and some loosens (Fig. 4c) distribute on the fracture wall near the outside surface. Fig. (4a) clearly exhibits that surface of the drill bit has been carburized. The gray area, which is apparently distinct from the white substrate, is identified as the carburized layer. Those dark dots and reticulation on it are believed to be the carbon-rich regions. Generally, they can be seen as harmful defects when they are not uniformly distributed. Fig. (4c) shows some loosens accompany those carbon-rich regions. All of them act as stress raisers and make the carburized layer risk crack initiation seriously under a uniaxial stress, which is especial for the high-strength steel [14 - 16].

Fig. (4). Defects in the carburized layer: (a) carbon-rich dots, (b) carbon-rich reticulations, (c) loosens.

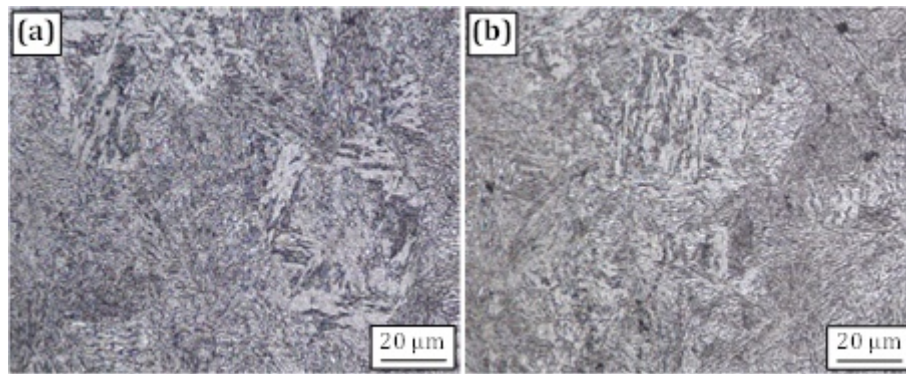
Images shown in Fig. (5) are metallographic structure of the substrate. Few differences of metallographic structure can be seen between the unqualified (Fig. 5a) and the qualified (Fig. 5b). They are both relatively pure acicular bainite, or it may be martensite due to high carbon content. It indicates that the cracking should not initiate from the substrate. Fig. (6) shows that numerous dark dots are dispersed in the carburized layer of the unqualified, which is barely seen in that of the qualified. Those dots represents the structural or/and compositional inhomogeneity, such as the carbon-rich dots. They are far denser than that in the substrate. It is consistent with what is seen in Fig. (4a).

Fig. (5). Metallographic structure of the substrates of (a) the unqualified and (b) the qualified respectively.

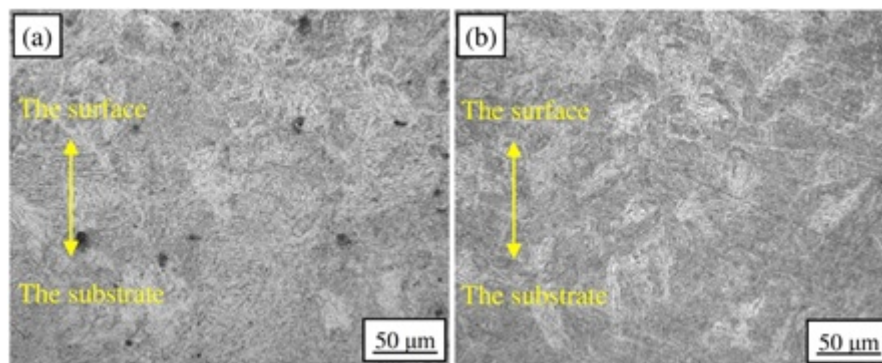
Fig. (6). Metallographic structure of the carburized layers of (a) the unqualified and (b) the qualified respectively.

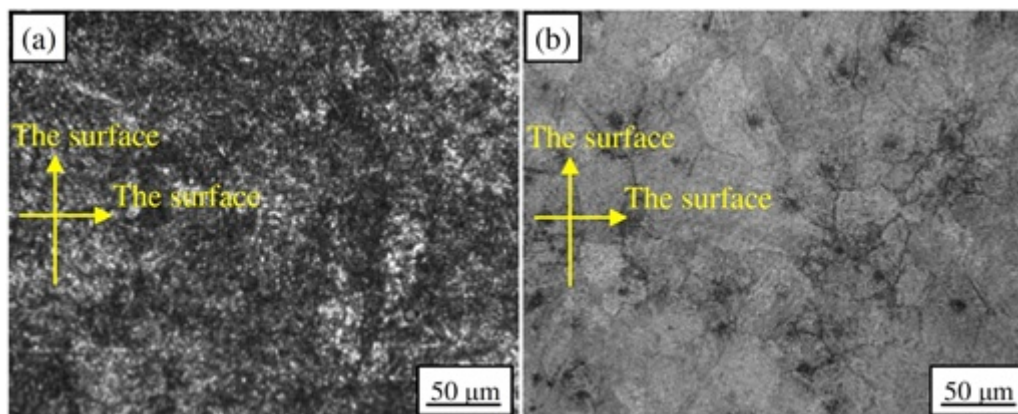
Metallographic observations have also been taken on the surfaces of the qualified and unqualified. The results are shown in Fig. (7a) shows that almost entire surface of the unqualified is blackened. Comparatively, that is much lighter on the surface of the unqualified, as shown in Fig. (7b). As they are etched in the same solution for the same time, this difference should not be induced by etching. It indicates that the unqualified has been over-carburized more seriously than the qualified.

Fig. (7). Metallographic structure of the surfaces of (a) the unqualified and (b) the qualified respectively.

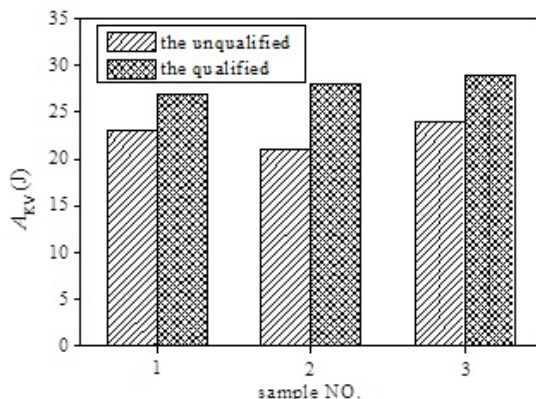
Fig. (8). Impact absorbing energy of the unqualified and the qualified drill bit.

Fig. (8) shows the charpy impact absorbed energy of three parallel V-notch samples cut from the unqualified and qualified respectively. Impact absorbed energy (A_{KV}) of the unqualified is about 20% on average lower than that of the qualified. It manifests that resistance to impact fracture of the unqualified deteriorate when compared to that of the qualified. But the degree is not great enough.

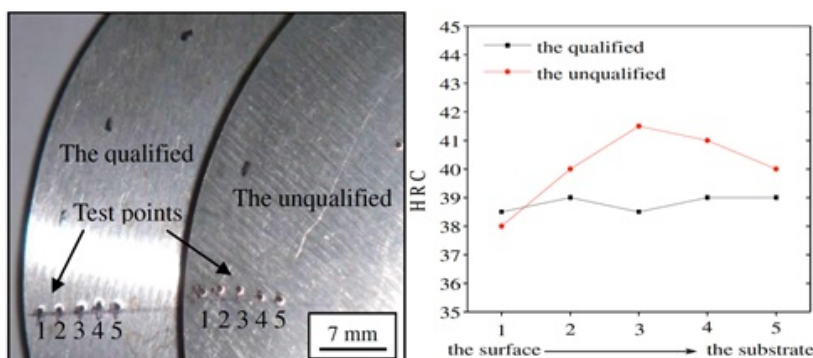
Fig. (9) shows the hardness distribution along the radial direction from the surface into the substrate. It indicates that hardness of the qualified is generally lower and distributes more uniformly than that of the unqualified. The inhomogeneity on hardness distribution reflects the inhomogeneity on internal residual stress and microstructure. Actually, difference between them is still in a rational range which can be taken as error of measurement. Besides, all of the five test points are located in the substrate. It indicates that the substrate of the unqualified possesses internal residual stress and microstructure similar to the substrate of the qualified. That is consistent with what is illustrated in Fig. (5).

Fig. (9). Hardness distribution along the radial direction from the surface into the substrate.

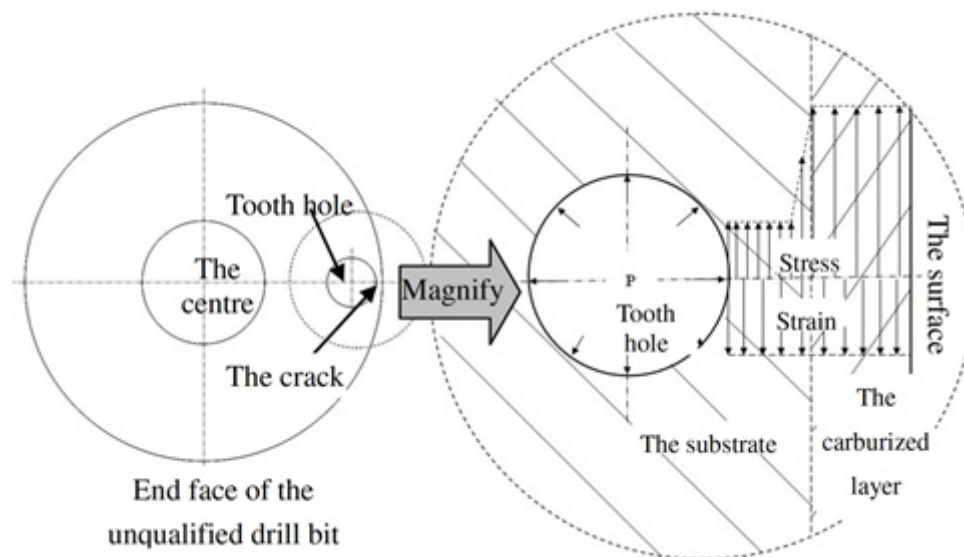
The drill teeth and the tooth holes are fastened by interference fit. Due to the different positions and asymmetry of tooth holes, tensile stress caused by interference fit generates a complex stress field at end face of the drill bit. According to previous study, the tensile stress level around the side teeth is much higher than that around the interior teeth [17]. Stress status on the edge of the end face nearby side teeth is simplified to the sketches shown in Fig. (10). The stress that the carburized layer suffered (σ_c) is much greater than the stress that the substrate suffered (σ_b). In addition, structure of the carburized layer is more defective than that of the substrate (see Figs. 5a, 6a). Greater stress and more defects make the carburized layer more likely initiate crack than the substrate do. Moreover, the stress concentration caused by structure asymmetry of fracture surface will further promote the crack initiation.

Fig. (10). Sketch of stress status around the crack on the edge of side tooth.

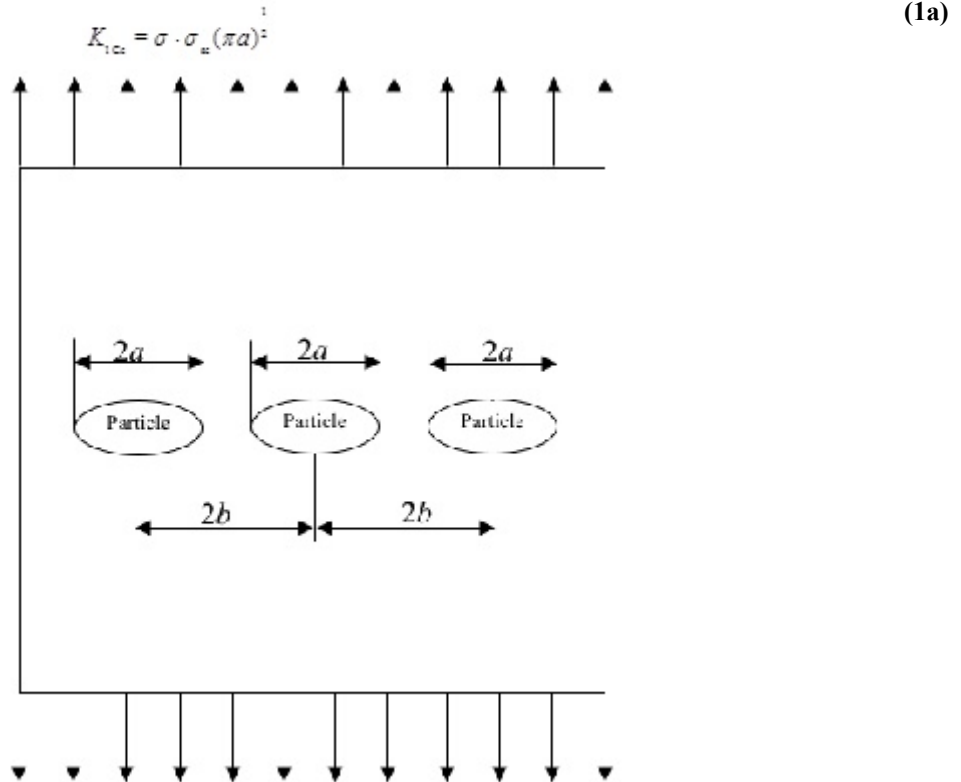
seen as ellipse particles. Fig. (11) illustrates the sketch of the stress unit. The radial stress can be ignored when compared with the much greater circumferential stress σ . The length of long axis is $2a$ and the distance between them along the axial direction is $2b$. According to fracture mechanics [18], fracture toughness of the carburized layer, K_{ICc} , can be expressed as follows:

Fig. (11). Stress unit containing defects in the carburized layer of the unqualified.
